West Side Fire Department - Station #1

Seismic Assessment

Prepared January 23, 2018

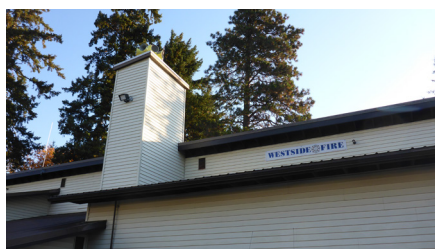
Figure 9
Hose Tower at West elevation
