West Side Fire Department - Station #2

Seismic Assessment

Prepared January 23, 2018

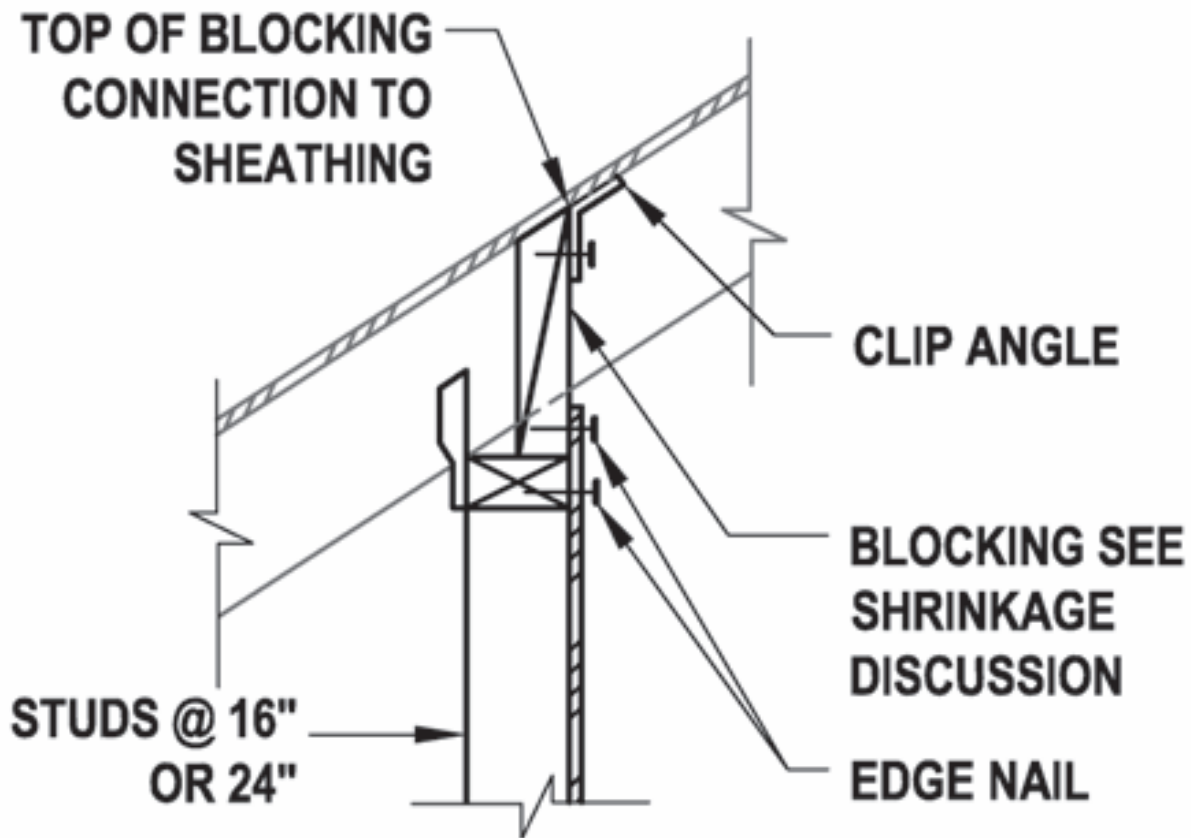
SK1

DIAPHRAGM TO SHEAR WALL CONNECTION

- Task 2: Where walls have structural sheathing, wood shear walls should be blocked and re-nailed with smaller nail spacing. Where walls have non-structural sheathing, wood shear walls should be blocked, re-sheathed with structural sheathing, and re-nailed with smaller nail spacing. See the Foundation Retrofit Plan for details and locations. Hold-downs (Figure 11) should be a Simpson HTT5 or equivalent with epoxy anchorage into existing foundation. See the Foundation Retrofit Plan for details and locations. Additional sill anchors need to be added at wood shear walls to connect them to their foundations. The on-center spacing of sill bolts should be 3 feet on center or less. Provide strapping above and below windows so lateral forces can be properly transferred to adjacent wall piers. Remove existing roofing, and provide additional nailing @ 4" on center into the existing diaphragm. See the Roof Retrofit Plan for details.

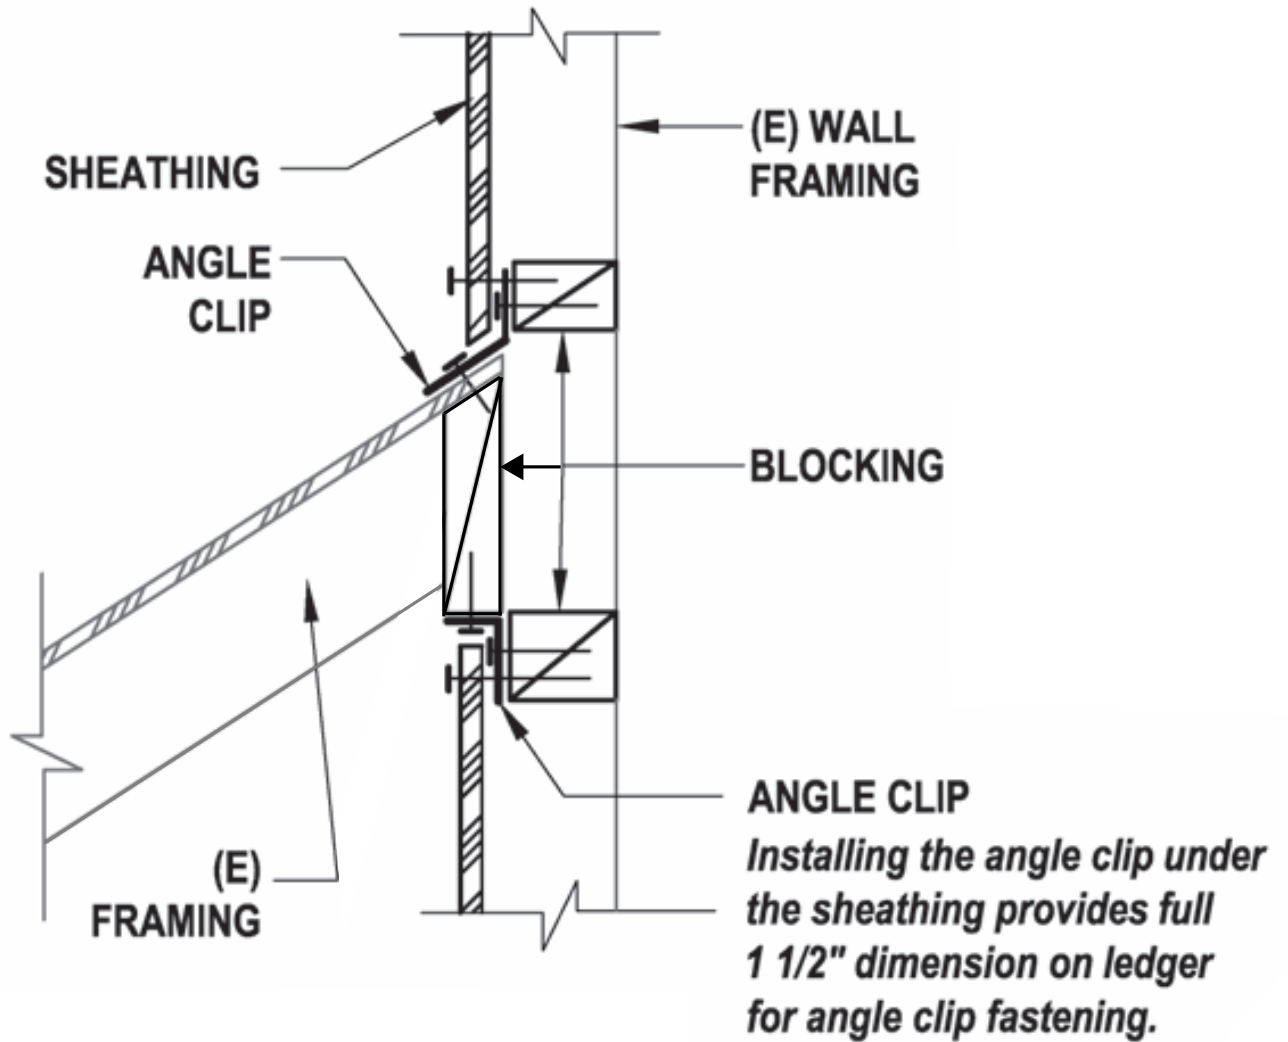
SK2

DIAPHRAGM TO SHEAR WALL CONNECTION

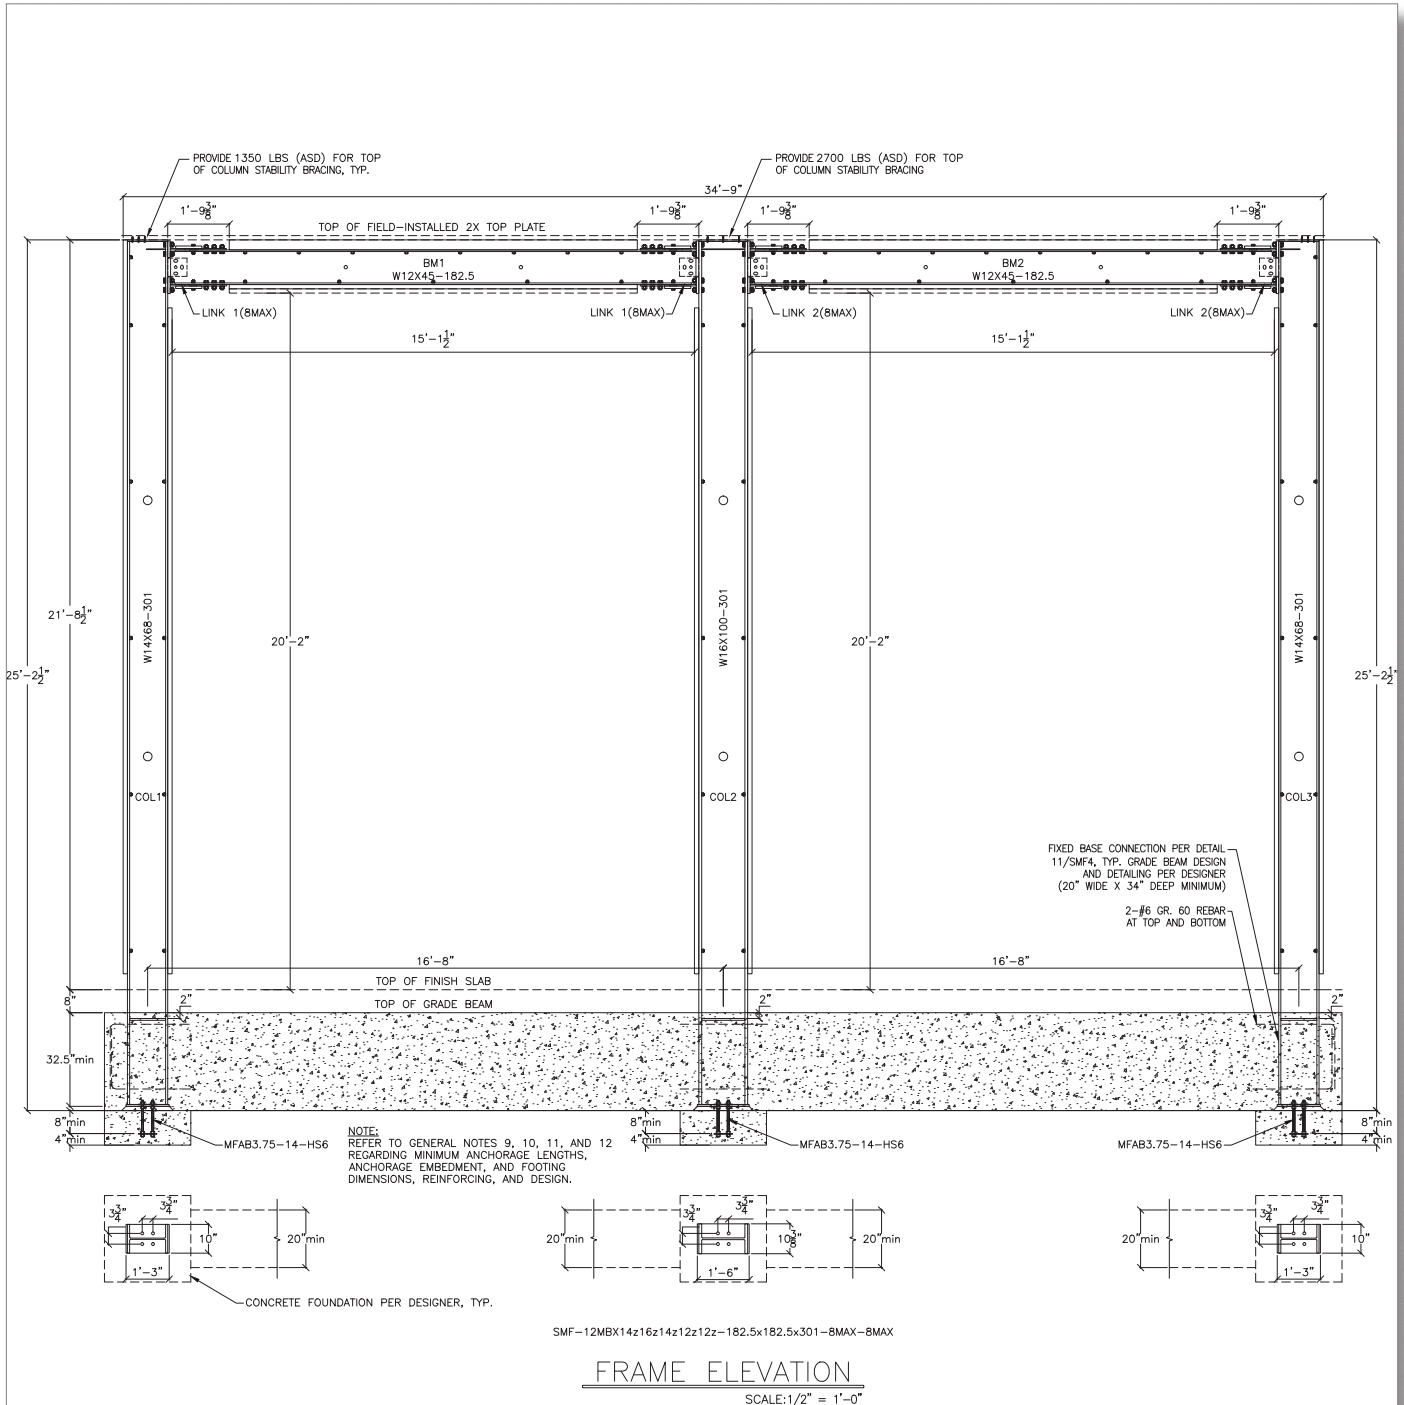
SK4

SIMPSON MOMENT FRAME ELEVATION

- Task 1: There is inadequate lateral support at the north side of the apparatus bay. Add two special moment frames at the existing bay doors. A continuous grade beam below the moment frame should be included to limit structure drift. Demolition of the existing slab as well as the existing building's foundations will need to occur to install the moment frame footings. Slab on grade to be replaced. Since there is some concern about the apparatus bay doors meeting the required thermal and seismic criteria, new apparatus bay doors are to be installed that will comply with current code criteria. See the Foundation/Roof Retrofit Plan for details and locations.
